CONNECTICUT RIVER BASIN
WOODSTOCK, VERMONT

COX DISTRICT RESERVOIR DAM
VT 00234

PHASE I INSPECTION REPORT
NATIONAL DAM INSPECTION PROGRAM

OCTOBER 1979

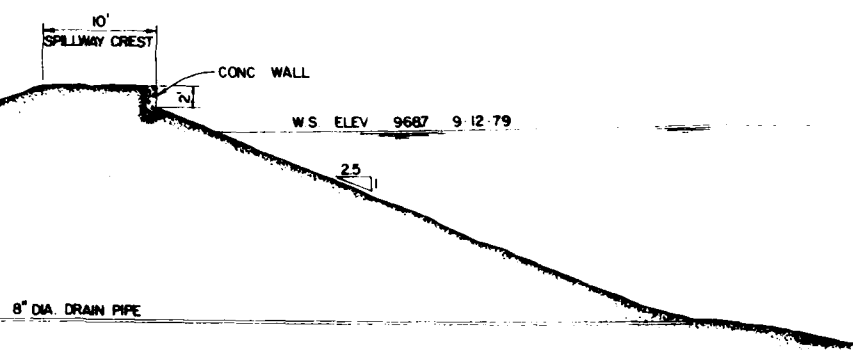
SECTION C-C

The pond is drained by an 8" Dia. pipe as shown in Section C-C, Figure 2/2. The pipe is controlled by valve located in concrete chamber. It was reported that pond drain is in good condition.

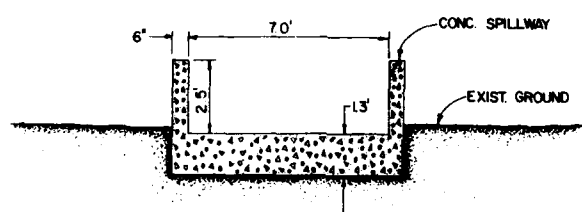
SECTION F-F

The spillway structure and spillway channel consists of a concrete slab and training walls, and a u-type structure as shown in Section F-F, Figure 2 of 2, Appendix B, and in Photos No. 11, 12 and 13. The spillway flow is controlled by the stoplogs, which are located in horizontal portion of the spillway, see Photo No. 10.

As discussed previously, there is a significant flow of water emerging from beneath the spillway structure onto the downstream slope. There is also water emerging from beneath the spillway below the downstream end of the structure. These observations indicated that a significant volume of water is flowing between the spillway structure and the embankment. There is also considerable concrete deterioration in the form of the cracks (walls and slab) and spalling. For the location of major cracks see the Plan of Spillway, Figure 1 of 2 in Appendix B. Visual inspection of the spillway structure indicates that it is in poor condition. In addition, leakage was occurring through the spillway stoplogs.

It is recommended that the owner remove the spillway stoplogs, and engage a qualified registered professional engineer to (1) investigate the cause and effect of the seepage beneath the spillway structure and to design remedial measures to prevent uncontrolled seepage in this area; (2) design an acceptable means of removing the trees and their roots from the dam and backfilling the voids with appropriate material; (3) determine what the dam is constructed of and if the concrete wall existing on the upstream slope is a core wall which extends into the foundation; and (4) investigate spillway adequacy and consider any modifications, if necessary. Remedial measures include the removal of brush from the downstream face of the dam, and establishment of a downstream warning system.
